Technical Memorandum

Project: GPC6, C-2012668-02, Task Order #39 Dallas CBD Second Light Rail Alignment (D2 Subway)

Subject: **FINAL DRAFT Technical Memorandum #15 - REVIEW**
Condition Inspection of the Elm Street Parking Garage

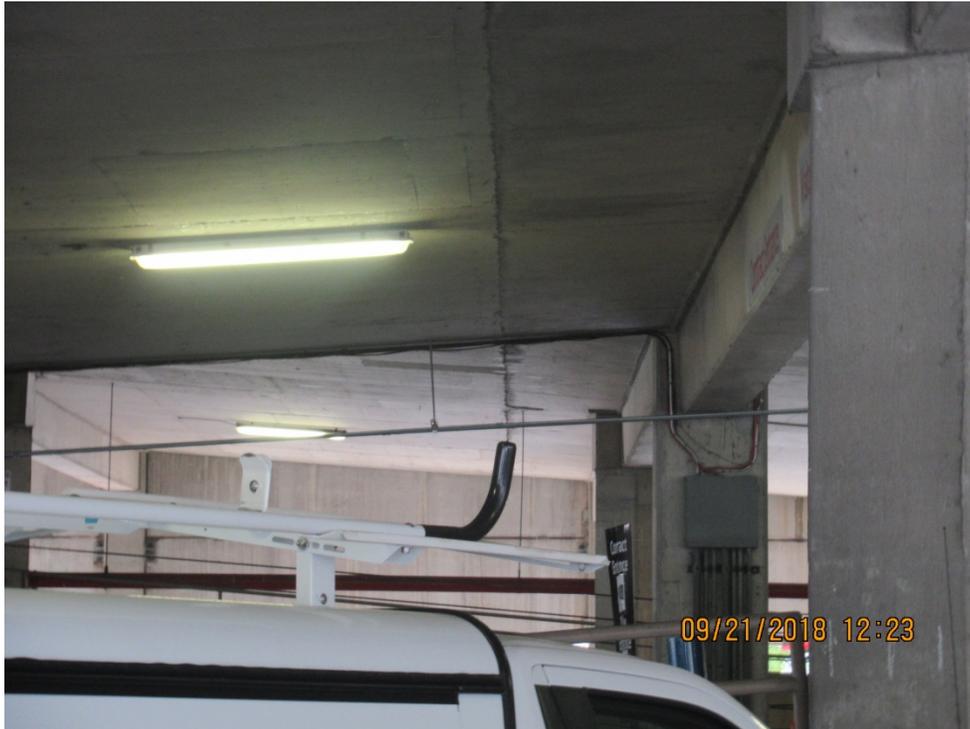
Overall, the concrete is in good condition. The parking garage has an easily identifiable expansion joint between the two parking structures (**Figure 2**). The parking decks are made of pre-cast concrete and are connected to the exterior walls through a series of typical joint details (**Figure 3**). These joints are also in relatively good condition. There is a slab-on-grade at street level, which does exhibit some cracking, likely due to settlement (**Figure 4**).

FIGURE 2. VIEW OF THE EXPANSION JOINT IN THE CEILING.

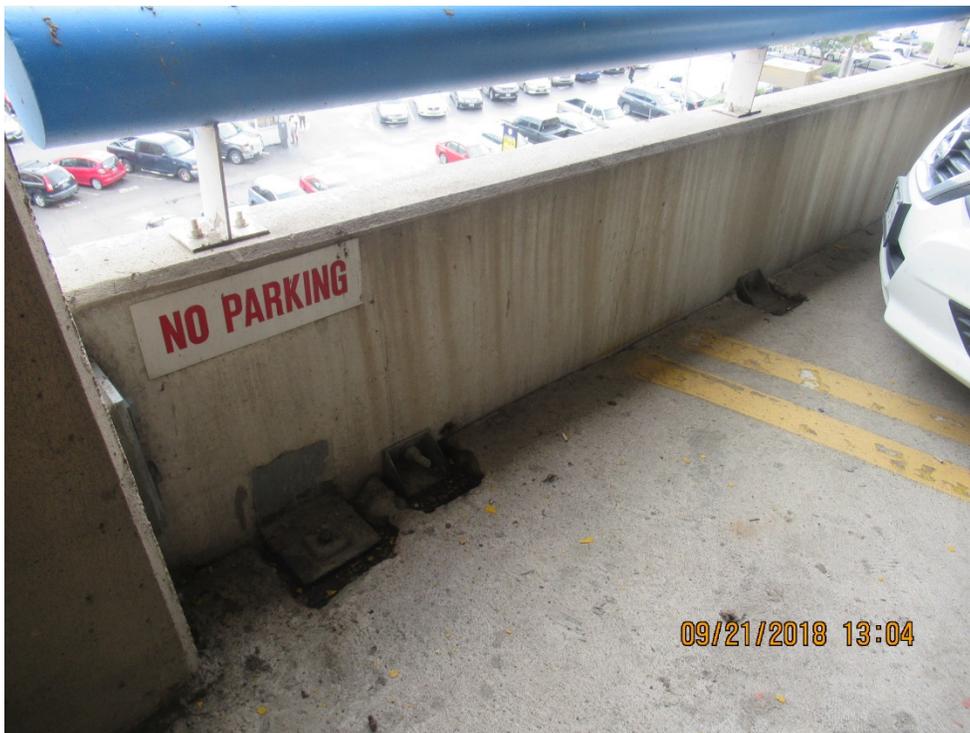
FIGURE 3. VIEW OF TYPICAL CONNECTIONS FOR THE PRE-CAST SLABS.

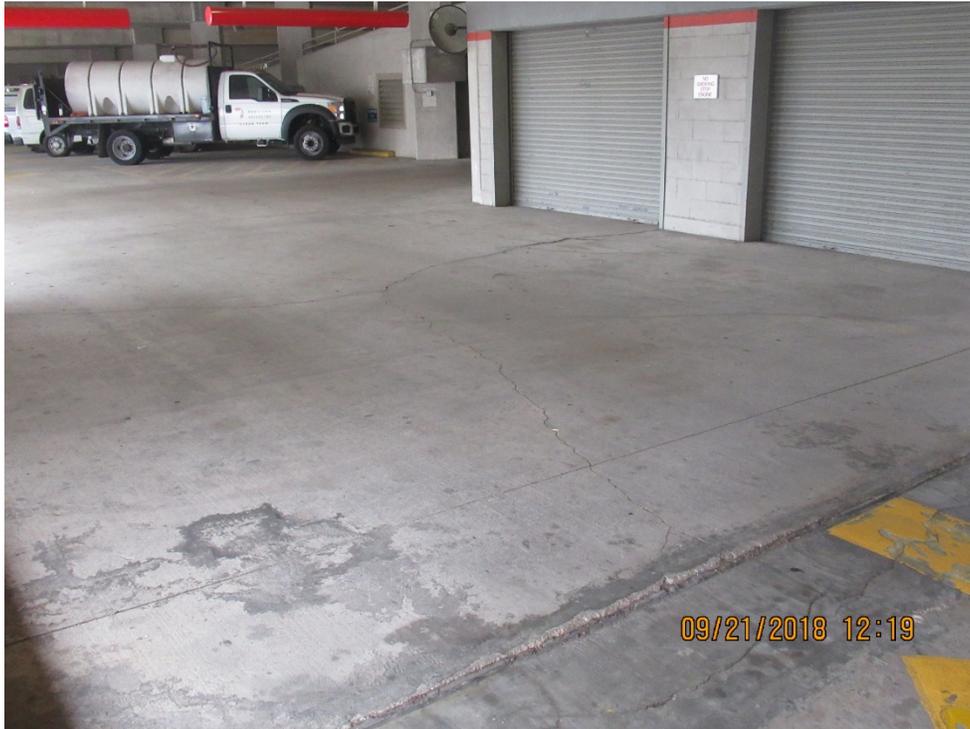
FIGURE 4. VIEW OF CONCRETE SLAB AT GRADE LEVEL.

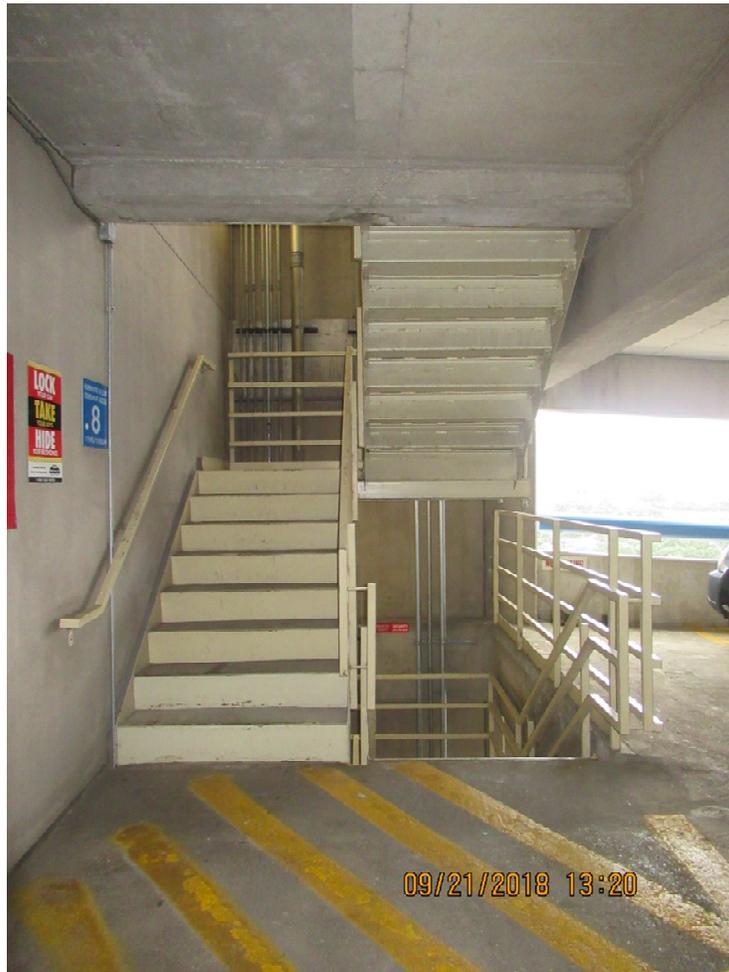
The only steel structures seen within the building are the staircases. These staircases consist of painted steel members, with reinforced concrete landings (**Figure 5**). The stairs do show signs of corrosion, warped treads, and overall deterioration of the concrete landings (**Figure 6**). This is expected to worsen over time if periodic maintenance to remedy

FIGURE 5. VIEW OF A TYPICAL STAIRWELL WITHIN THE GARAGE.

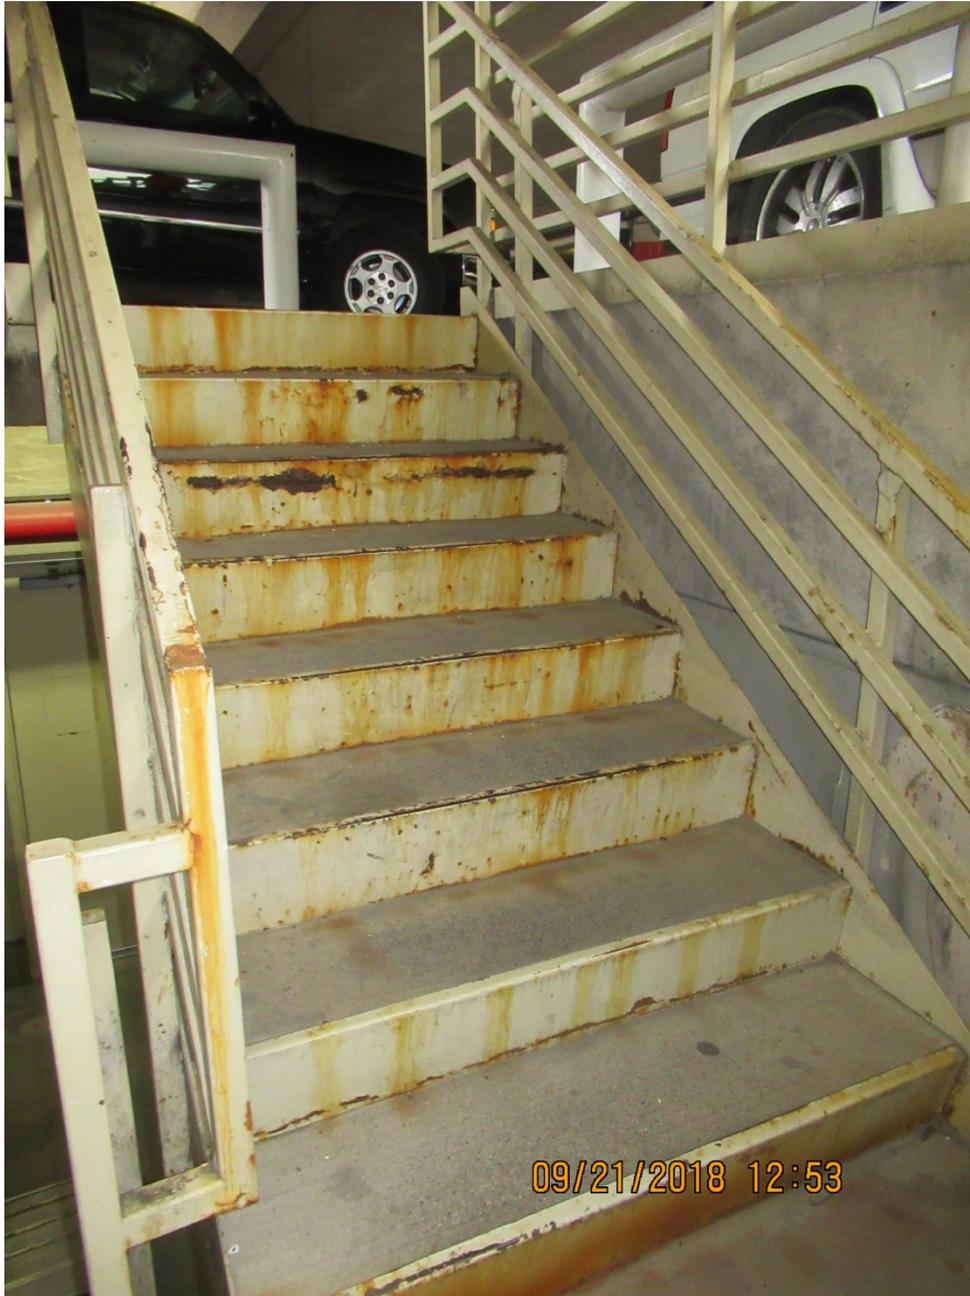
corrosion is not timely implemented. Existing conditions and repair or replacement of these elements would not impact the structural integrity of the overall parking garage, but may have some negative impacts of the garage's functional use.

FIGURE 6. VIEW OF TYPICAL DETERIORATION SEEN IN MULTIPLE STAIRWELLS, ACROSS MULTIPLE LEVELS.

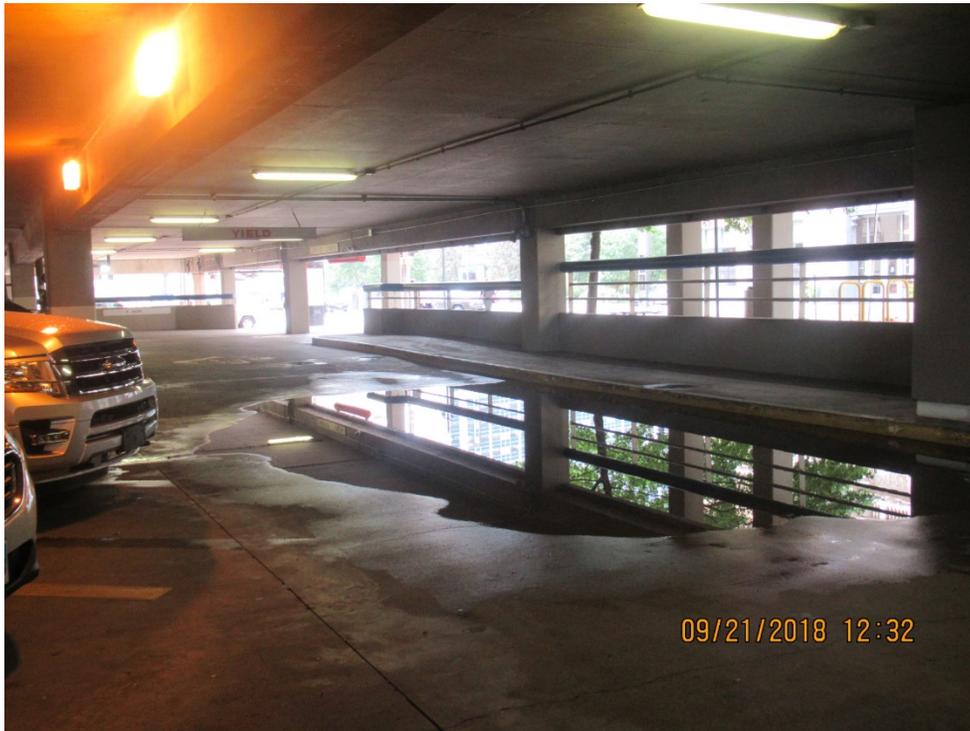
This visual inspection of the parking garage was conducted during a heavy rainfall. Therefore, it was possible to observe the drainage of the structure. The structure does have areas where the drains are clogged and/or not working properly (**Figure 7**), as well as areas of ponding where there is no drain at all (**Figure 8**). With the passage of time, this could lead to additional long-term and/or permanent issues or problems with the structure.

FIGURE 7. VIEW OF PONDING WITHIN THE GARAGE WHERE THE DRAIN IS CLOGGED/NOT FUNCTIONING PROPERLY.

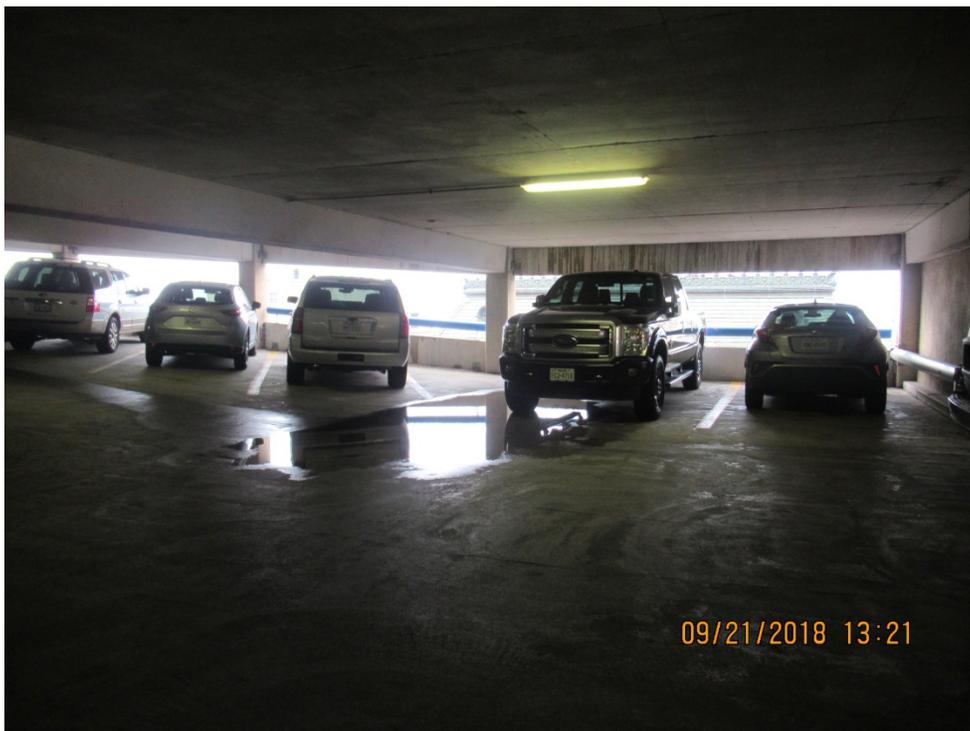
FIGURE 8. VIEW OF PONDING WITHIN THE GARAGE WHERE THERE IS NO DRAIN PRESENT.

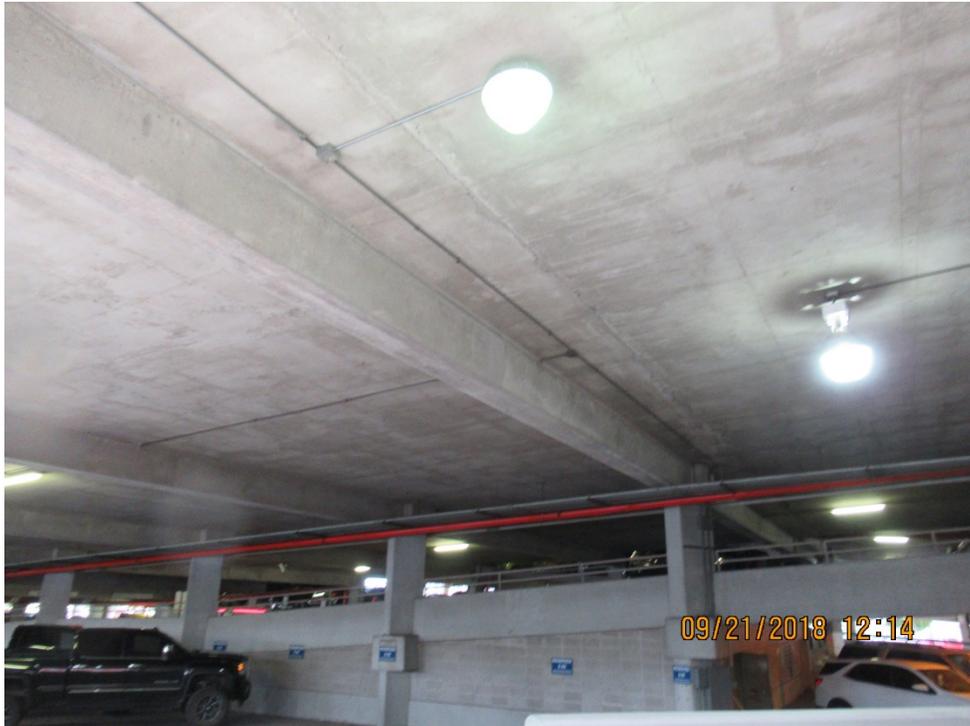
FIGURE A- 1. GENERAL VIEW OF THE CEILING, FROM GROUND LEVEL, WHERE A CONSTRUCTION JOINT IS PRESENT.

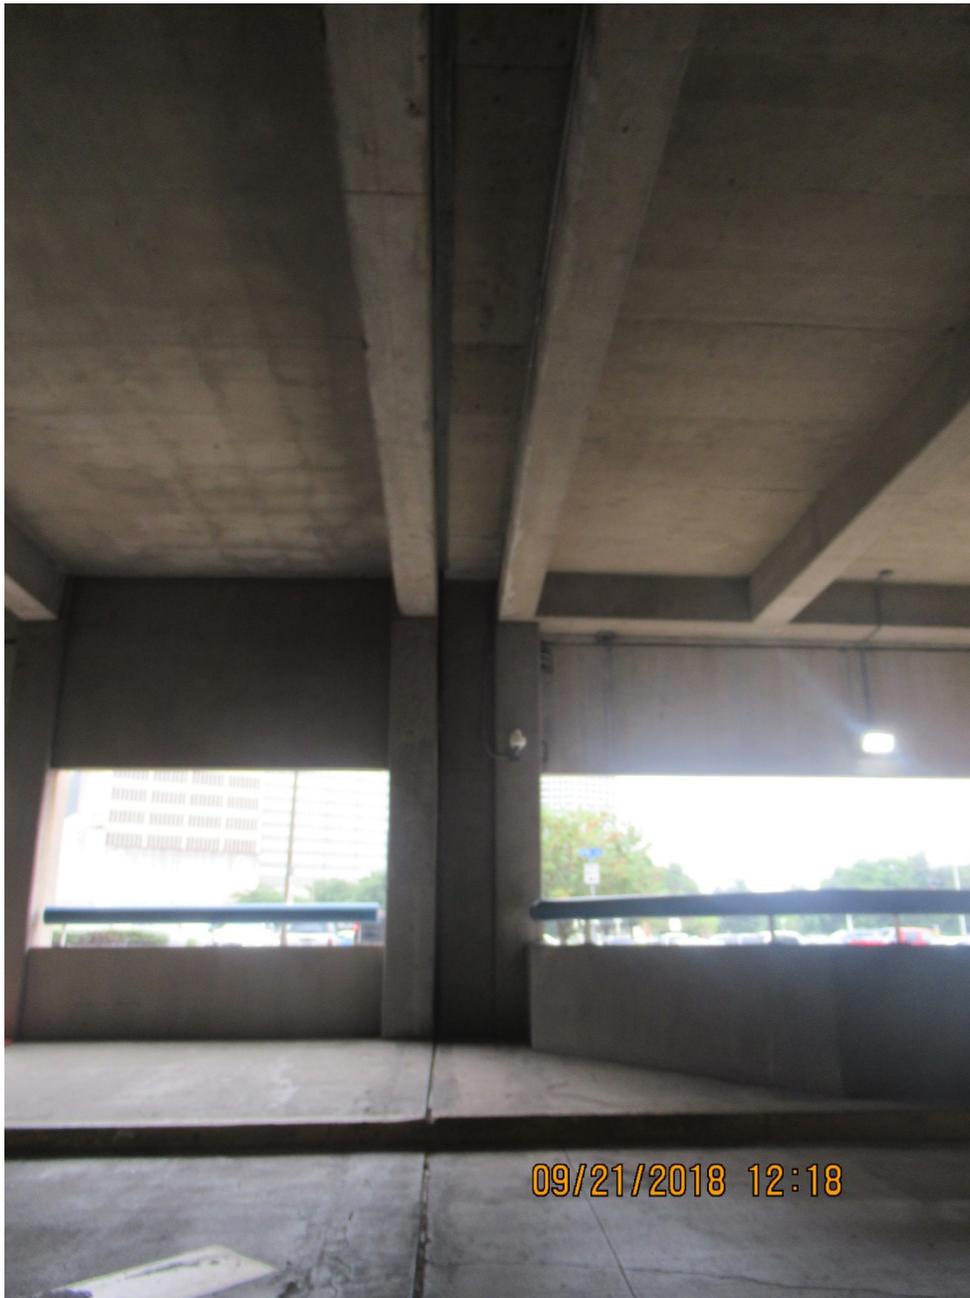
FIGURE A- 2. VIEW OF THE SECTION WHERE THE PARKING GARAGE STRUCTURES MEET.

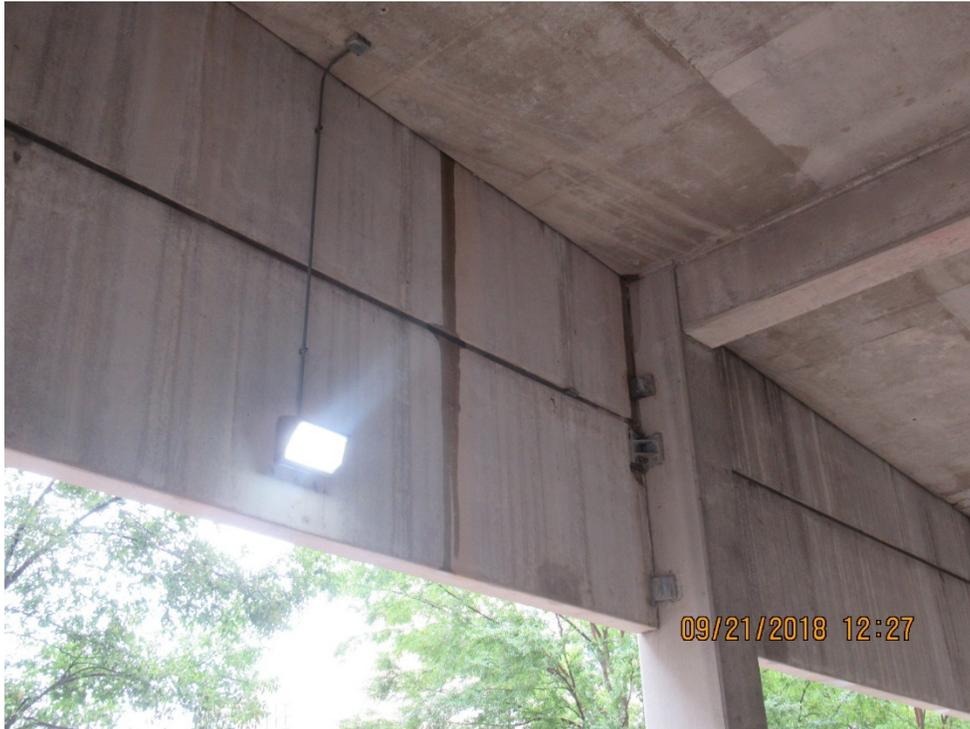
FIGURE A- 5. TYPICAL PRE-CAST CONNECTIONS.

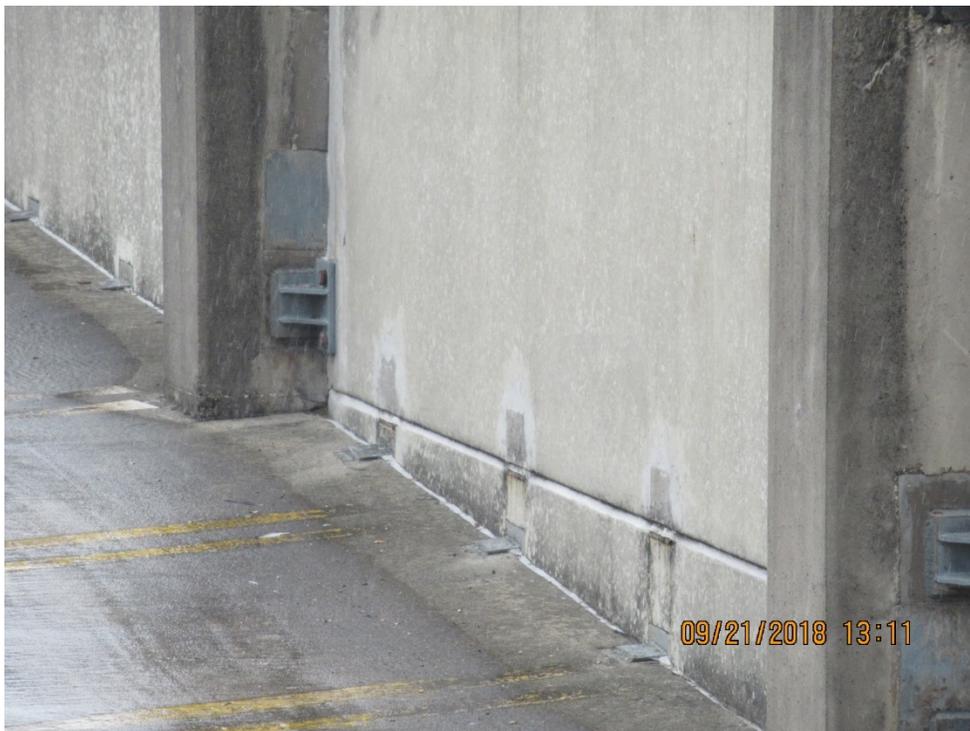
FIGURE A- 6. PRE-CAST CONCRETE CONNECTIONS AT ROOF LEVEL.
